## WOOD FLOOR TRUSSES

While following up on the subject matter, a couple of developments regarding this parallel chord floor truss system have been discovered. ***Open Joist 2000*** is the trade name for this new pre-fabricated floor joist system. The company, Toiture Mauricenne, is based in Canada with US distributors in Connecticut, Maine, Massachusetts, Michigan, New Hampshire, and Pennsylvania (our neighbors). The system is a patented design whose selling point promises to reduce floor squeaking, better absorb floor vibrations, and eliminate the need for dropped ceilings because of the open web design (HVAC duct work can pass thru). The system utilizes dimensional lumber with notched and glued finger joints absent of any other nails or other connectors. The glue is Phenol Resorcinol which, according to the manufacturer, is water resistant and flame retardant (highly debatable). After contacting one of the distribution/manufacturing plants, it was discovered that ***Open Joist 2000*** has been subjected to the ASTM E119 standard fire resistance test required by UL (inconclusive due to the unrealistic, pristine test structure), is approved under the IBC (International Building C

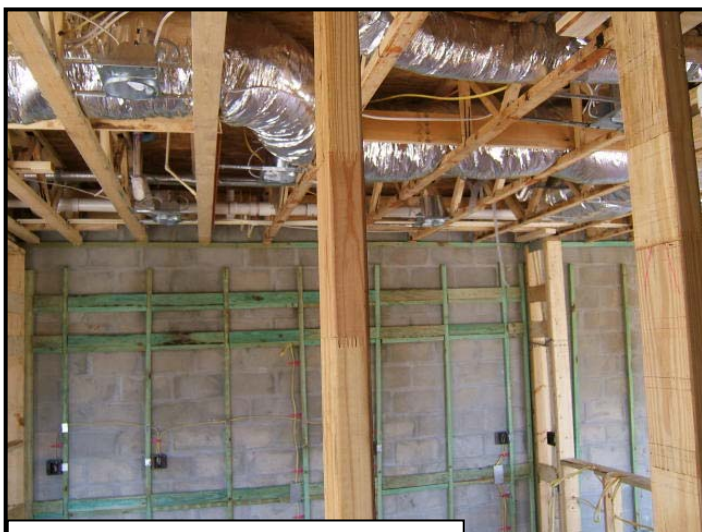
HVAC Duct Work passing thru

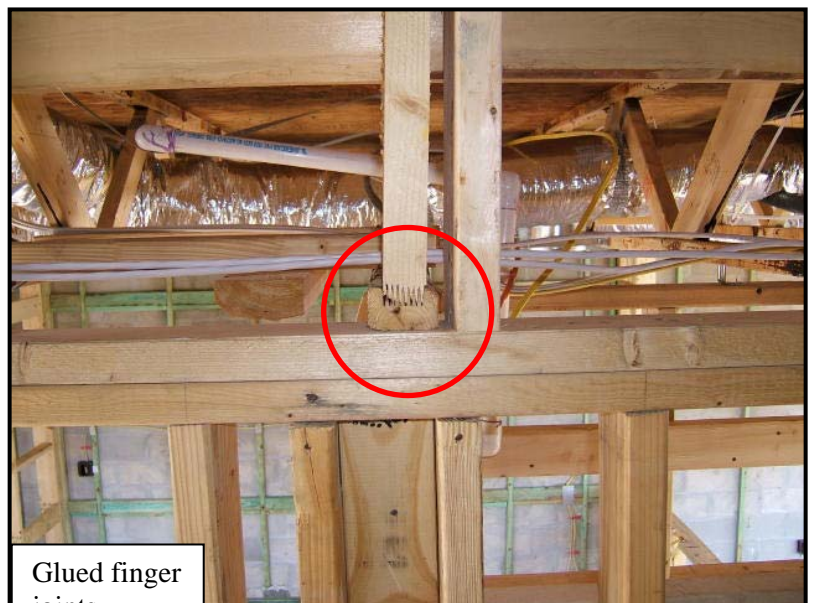
Glued finger joints

3. Failing connectors. Gusset plates, when heated, can damage wood fibers holding the teeth in place. Glue used in the notched finger joints, when heated, may loose its connectivity. Both instances may jeopardize the integrity of the system.

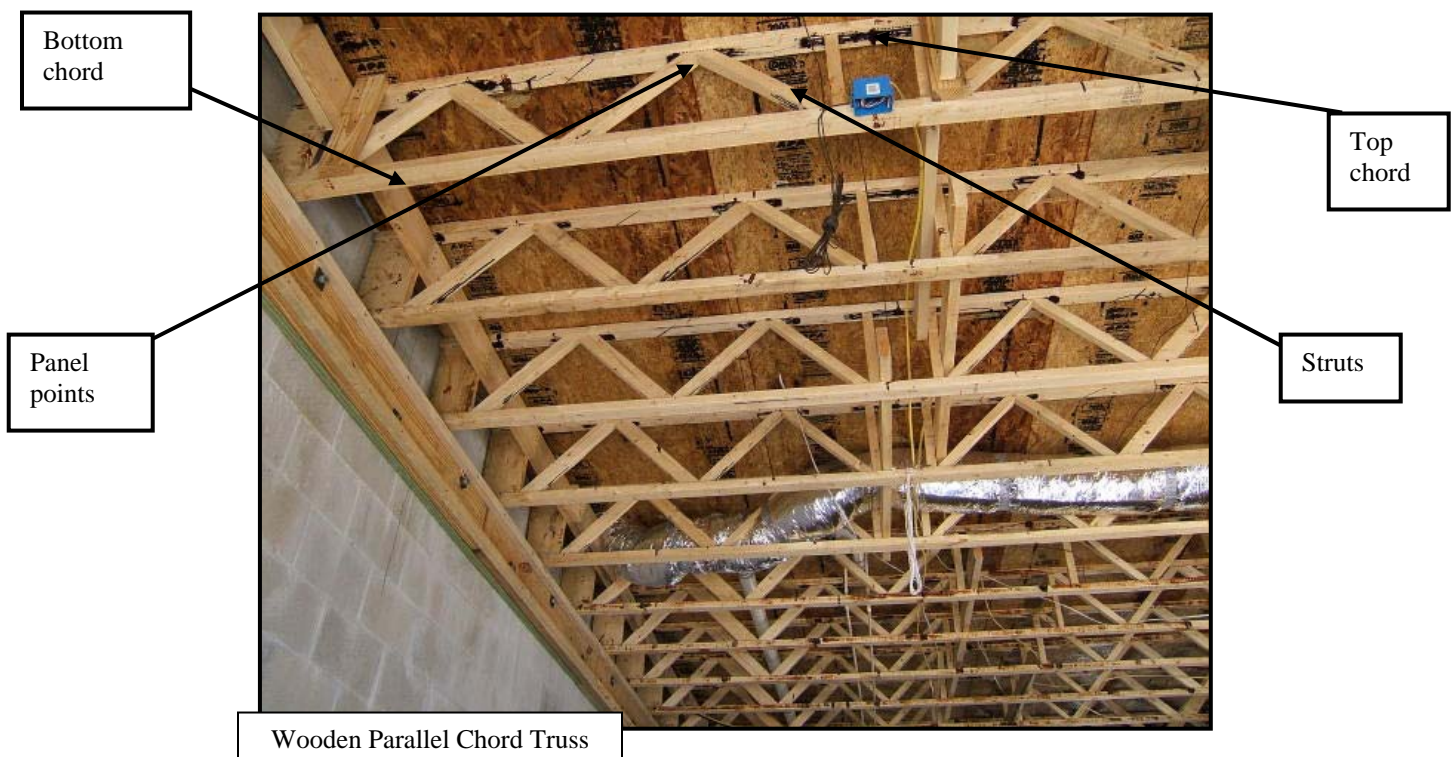
The top chord of a truss is in compression while the bottom chord is in tension. Damaged or decreased material in the bottom or top chords will increase the tensile forces affecting stability. The engineering advantage of the truss system is that it provides separation of compression and tensile stresses while utilizing a minimum of material. Every part of a truss, from the chord to its connectors, is interdependent and relies upon such for its strength.

Let's review some basic facts concerning trusses. According to Francis Brannigan's **Building Construction for the Fire Service**, a truss is a framed unit consisting of a triangle or group of triangles arranged in a single plane in such a manner that loads applied at the points of intersections of the members will cause only direct stresses in the members; loads applied between these points cause flexural stresses. The top and bottom members of the truss are called **chords**. The compressive connecting members are called **struts**. The tensile connecting members are called **ties**. Connections are called **panel points**. As a group, the ties, strut, and panel points are collectively called the **web**. It is lighter in weight than solid construction, provides long spans allowing maximum flexibility in the use of space, and arrives to the construction site pre-fabricated.

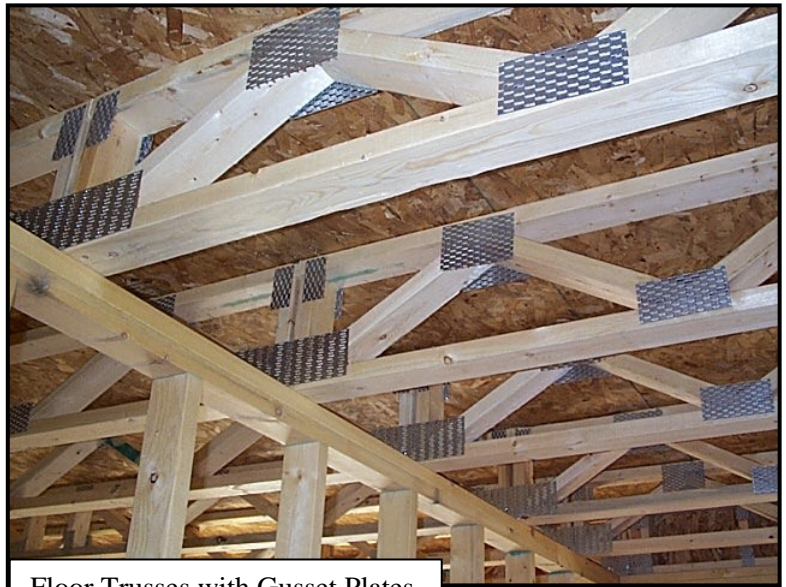
Floor Trusses with Gusset Plates

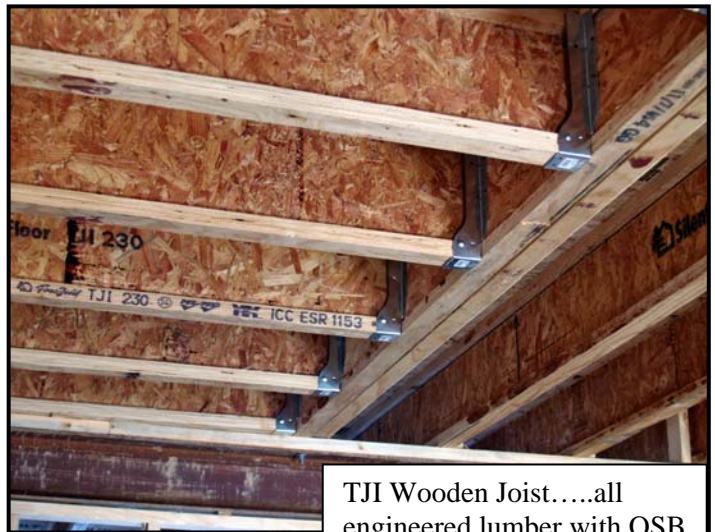
TJI Wooden Joist.....all engineered lumber with OSB laminated webbing. Supported by joist hangers or “saddle straps”
